Built for Foul Weather

A new home on the Oregon coast blends reclaimed materials with durable details

BY NATHAN GOOD

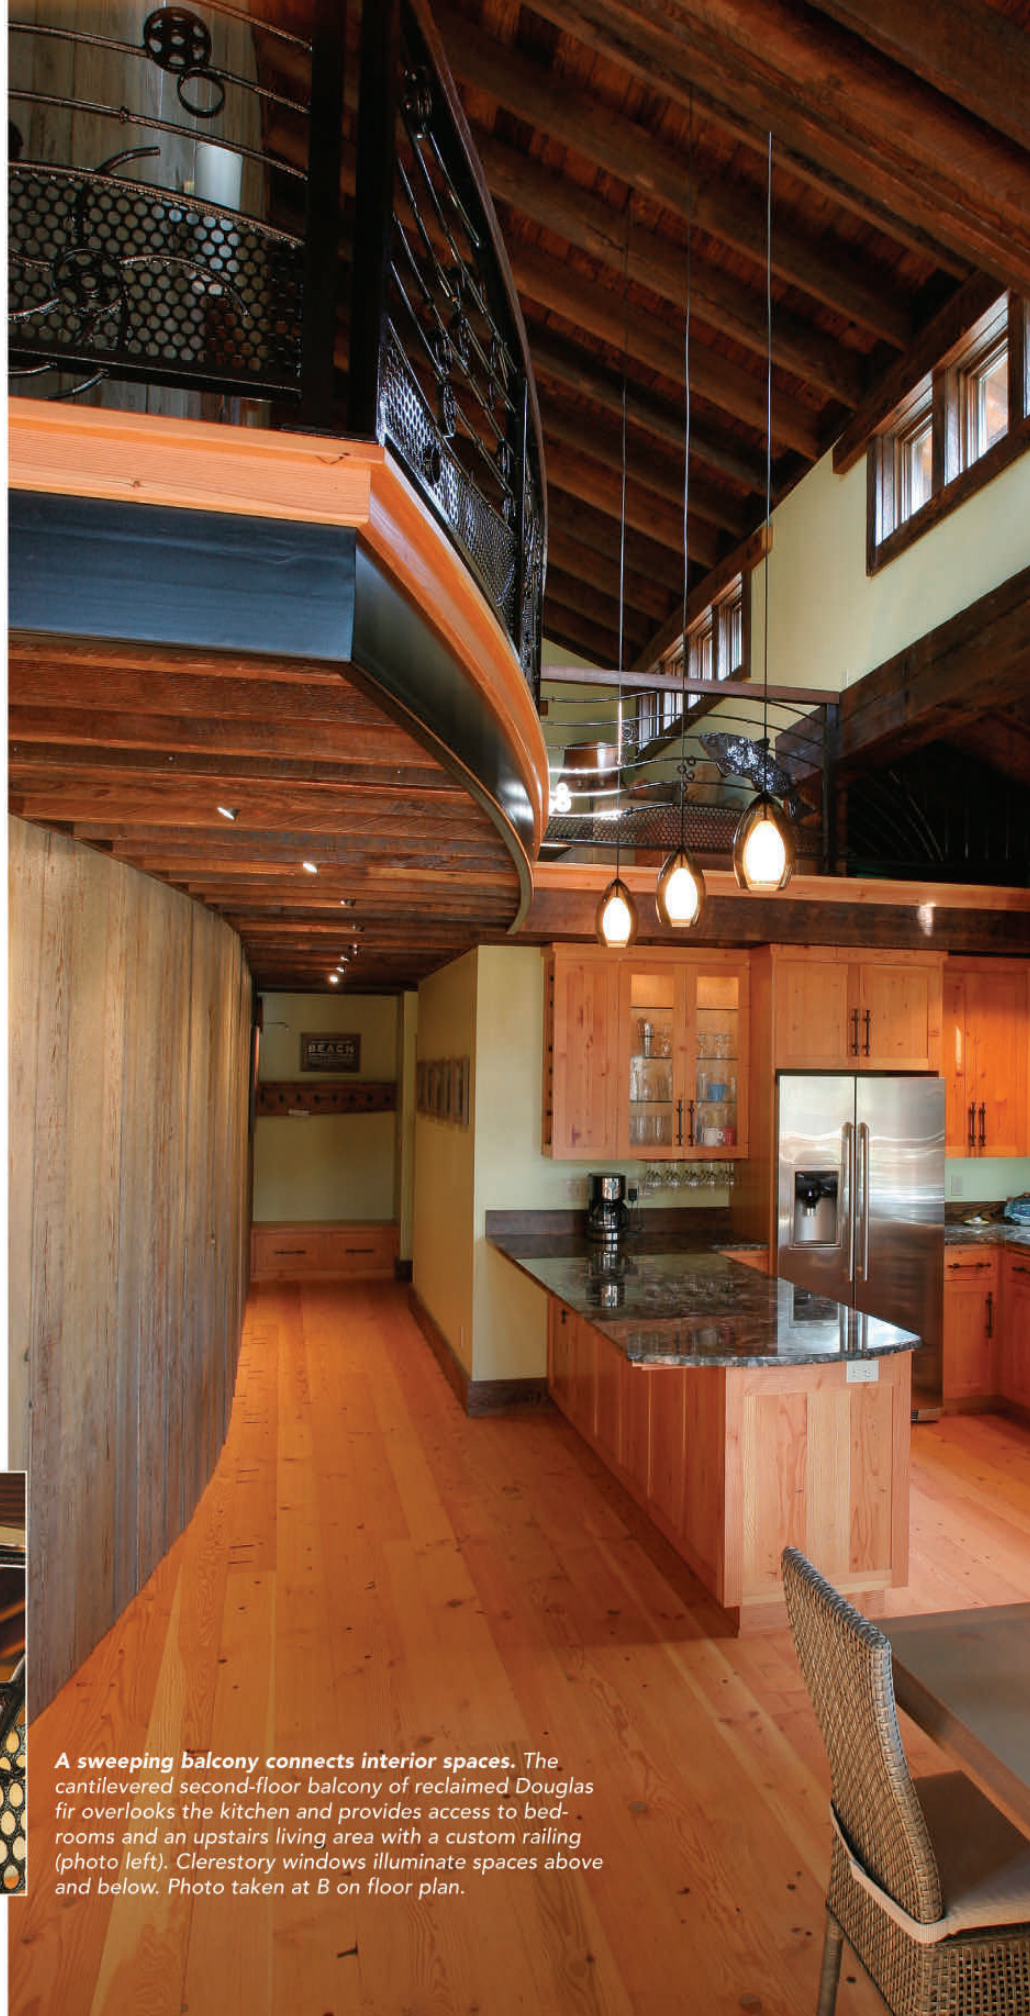
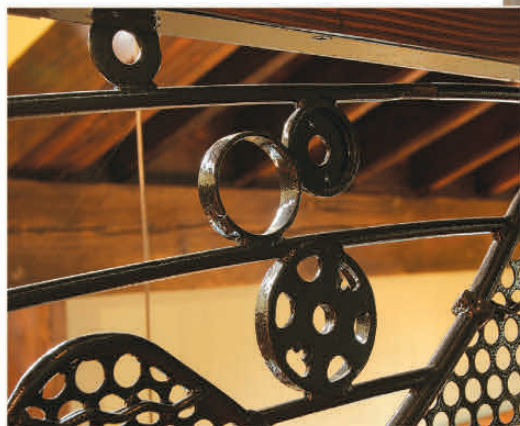
A sweeping balcony connects interior spaces. The cantilevered second-floor balcony of reclaimed Douglas fir overlooks the kitchen and provides access to bedrooms and an upstairs living area with a custom railing (photo left). Clerestory windows illuminate spaces above and below. Photo taken at B on floor plan.

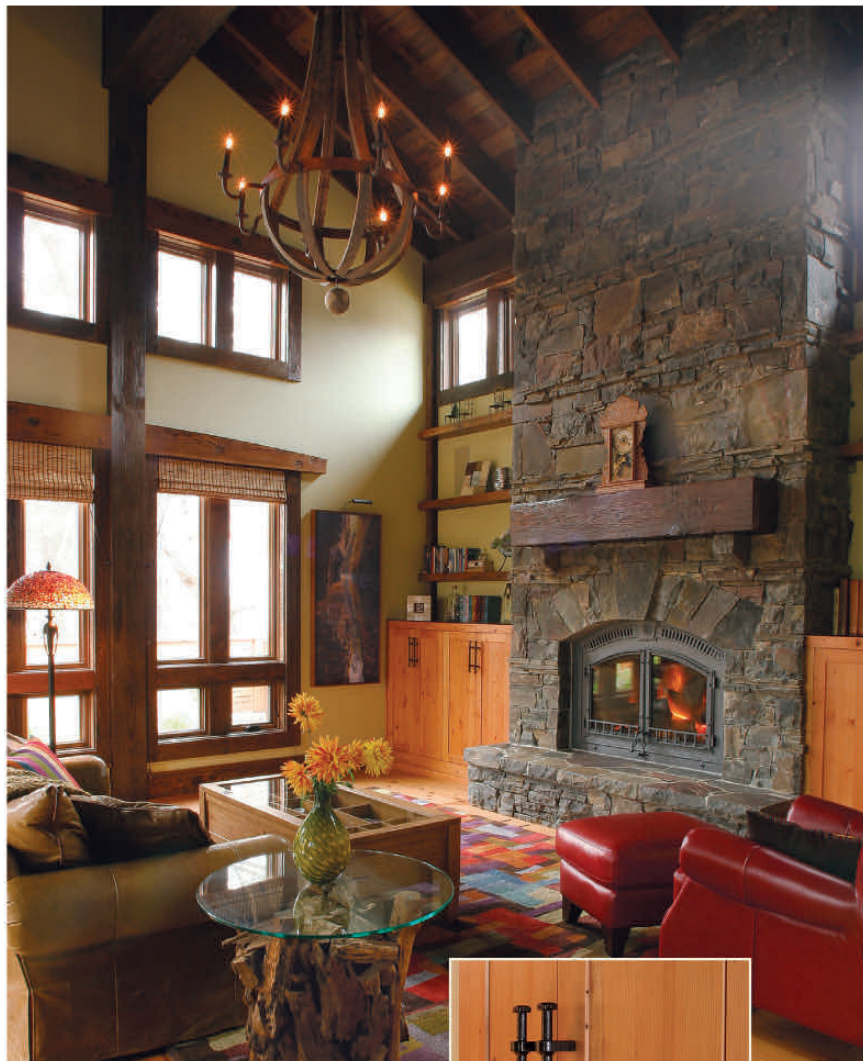
After deconstruction, we kept the materials in a heated warehouse with good airflow and delivered the lumber with a moisture content of 10% to 12%. Joe Vondrak of Pacific Crest Construction in Portland, Ore., recommended using a Makita power-wheel brush sander (model

9741) with an SC-80 nylon wheel brush to clean up all the lumber. The bristle brush beautifully highlights the texture and grain in the wood, which makes it ideal for cleaning up reclaimed and rough-sawn material.

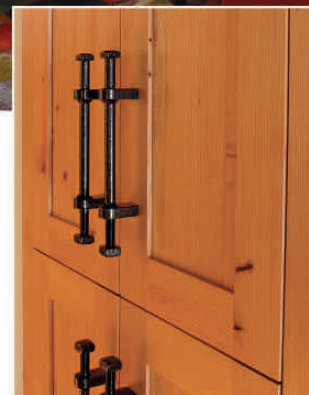
A great room with fine details. Flooded with daylight, the living room is anchored by a chimney made of locally quarried stone. Reclaimed Douglas fir was used as framing, flooring, trim, and shelving, and as material for the built-in cabinets. Old bolts were powder-coated and used as cabinet hardware. Photo taken at C on floor plan.
